REPORT NO. NADC-83123-60

PERFORMANCE EVALUATION OF THE HI-SPEED EJECTION LIMB PROTECTION SYSTEMS (HELPS)

Ken Miller
Aircraft and Crew System Technology Directorate
NAVAL AIR DEVELOPMENT CENTER
Warminster, PA 18974

PHASE REPORT
PROGRAM ELEMENT-63216N
Work Unit No.-W0584001

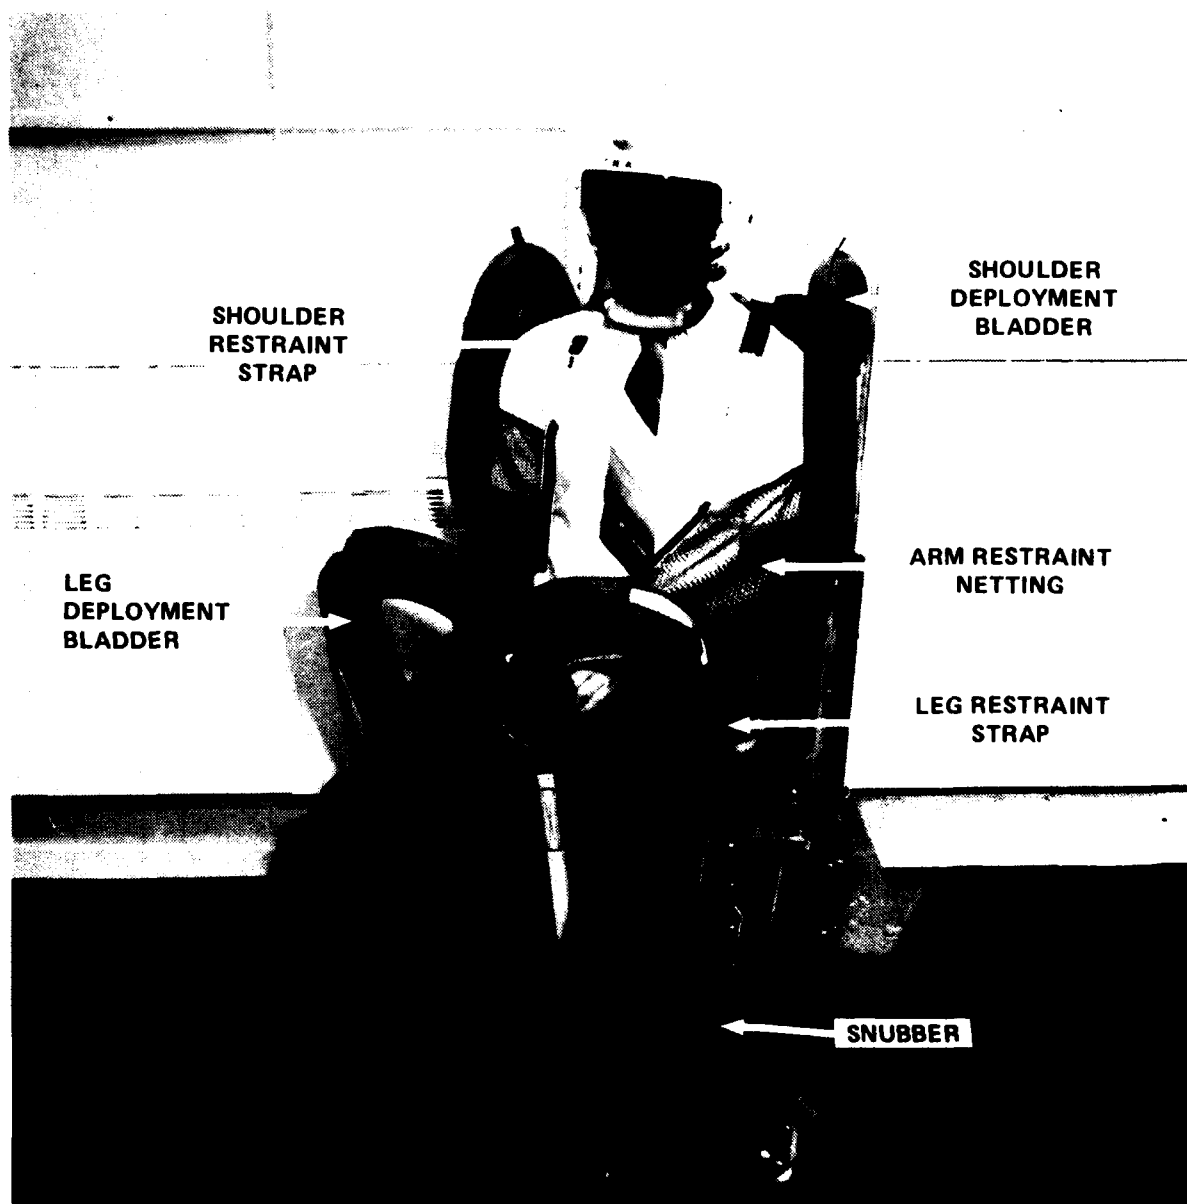
Figure 2. Helps Properly Deployed

The HELPS prototype is shown in figure 1 in the stowed position in the MPES seat. As can be seen the system is completely seat mounted, primarily in the back and bottom cushions. The aircrewman is not required to don or connect anything. Figure 2 shows the system actuated and the HELPS deployed. Tension has been applied to capture and restrain the arms and legs.

As figure 2 illustrates, the inflatable bladders are used to deploy the HELPS. It includes 3500 pound Kevlar straps and netting which accomplish the actual restraint. The bladders may be inflated by gas generators of the type used in inflatable automotive impact systems or by high pressure stored gas.

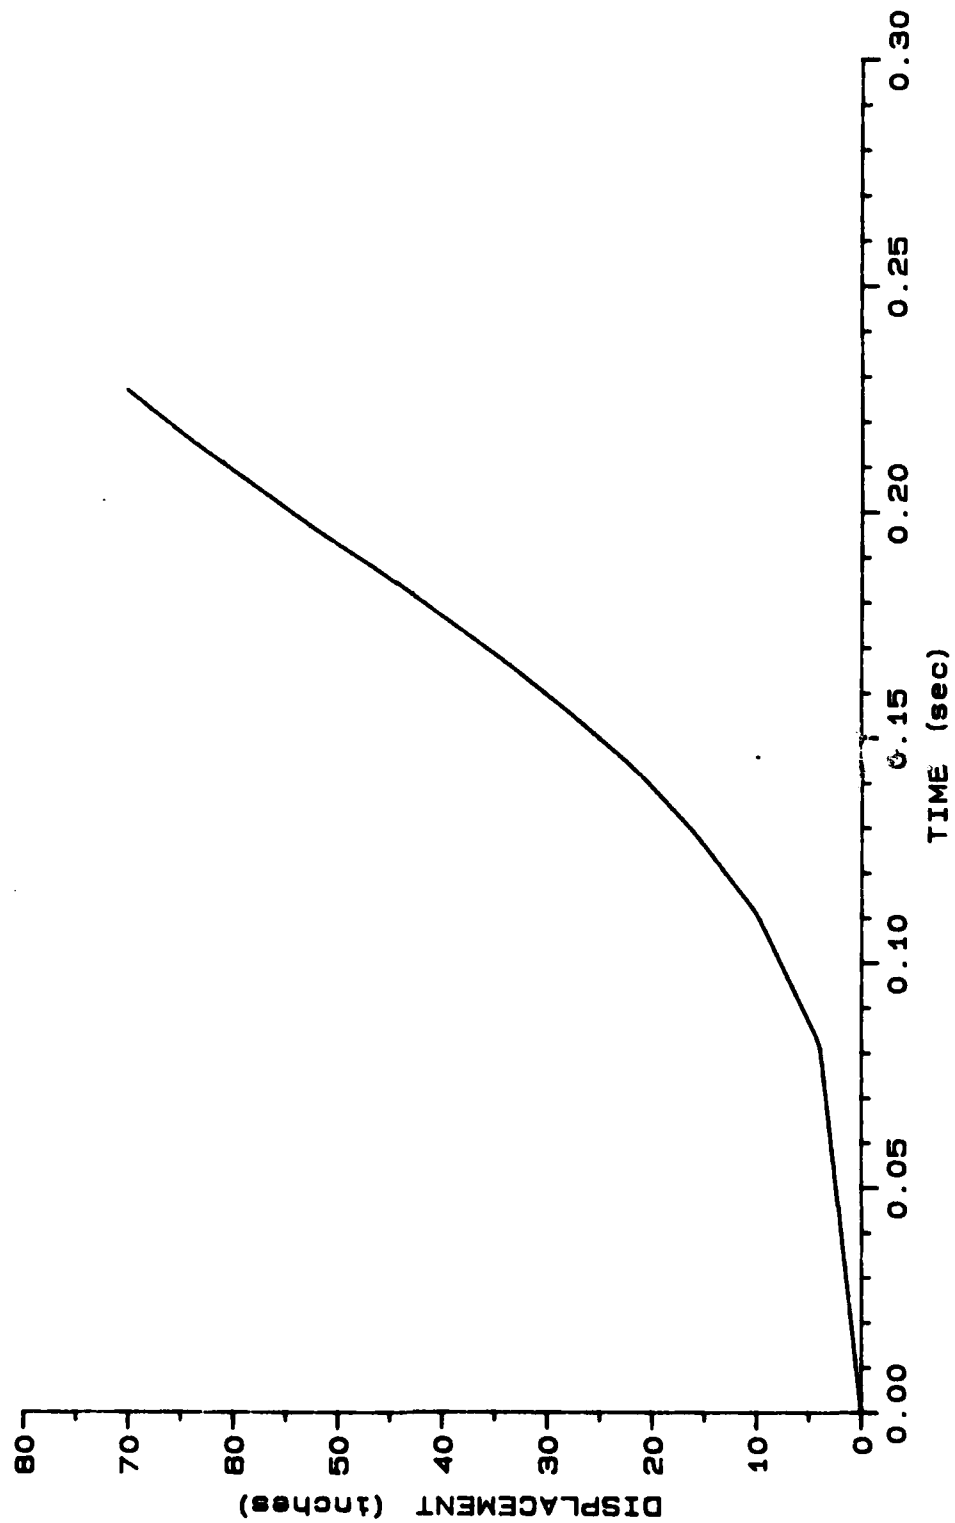
Figure 10. Seat Displacement vs Time

The ejection tower evaluation was conducted to demonstrate the ability of the HELPS to both deploy and entrap the occupants limbs during the cinch-up phase. Eight ejection tower tests were conducted in July of 1981, using both five and ninety five percentile dummies. Data from these tests are shown in table II. Typical seat displacement-vs-time curves and cinch-up pull force-vs-time curves are shown in figures 10 and 11 respectively.

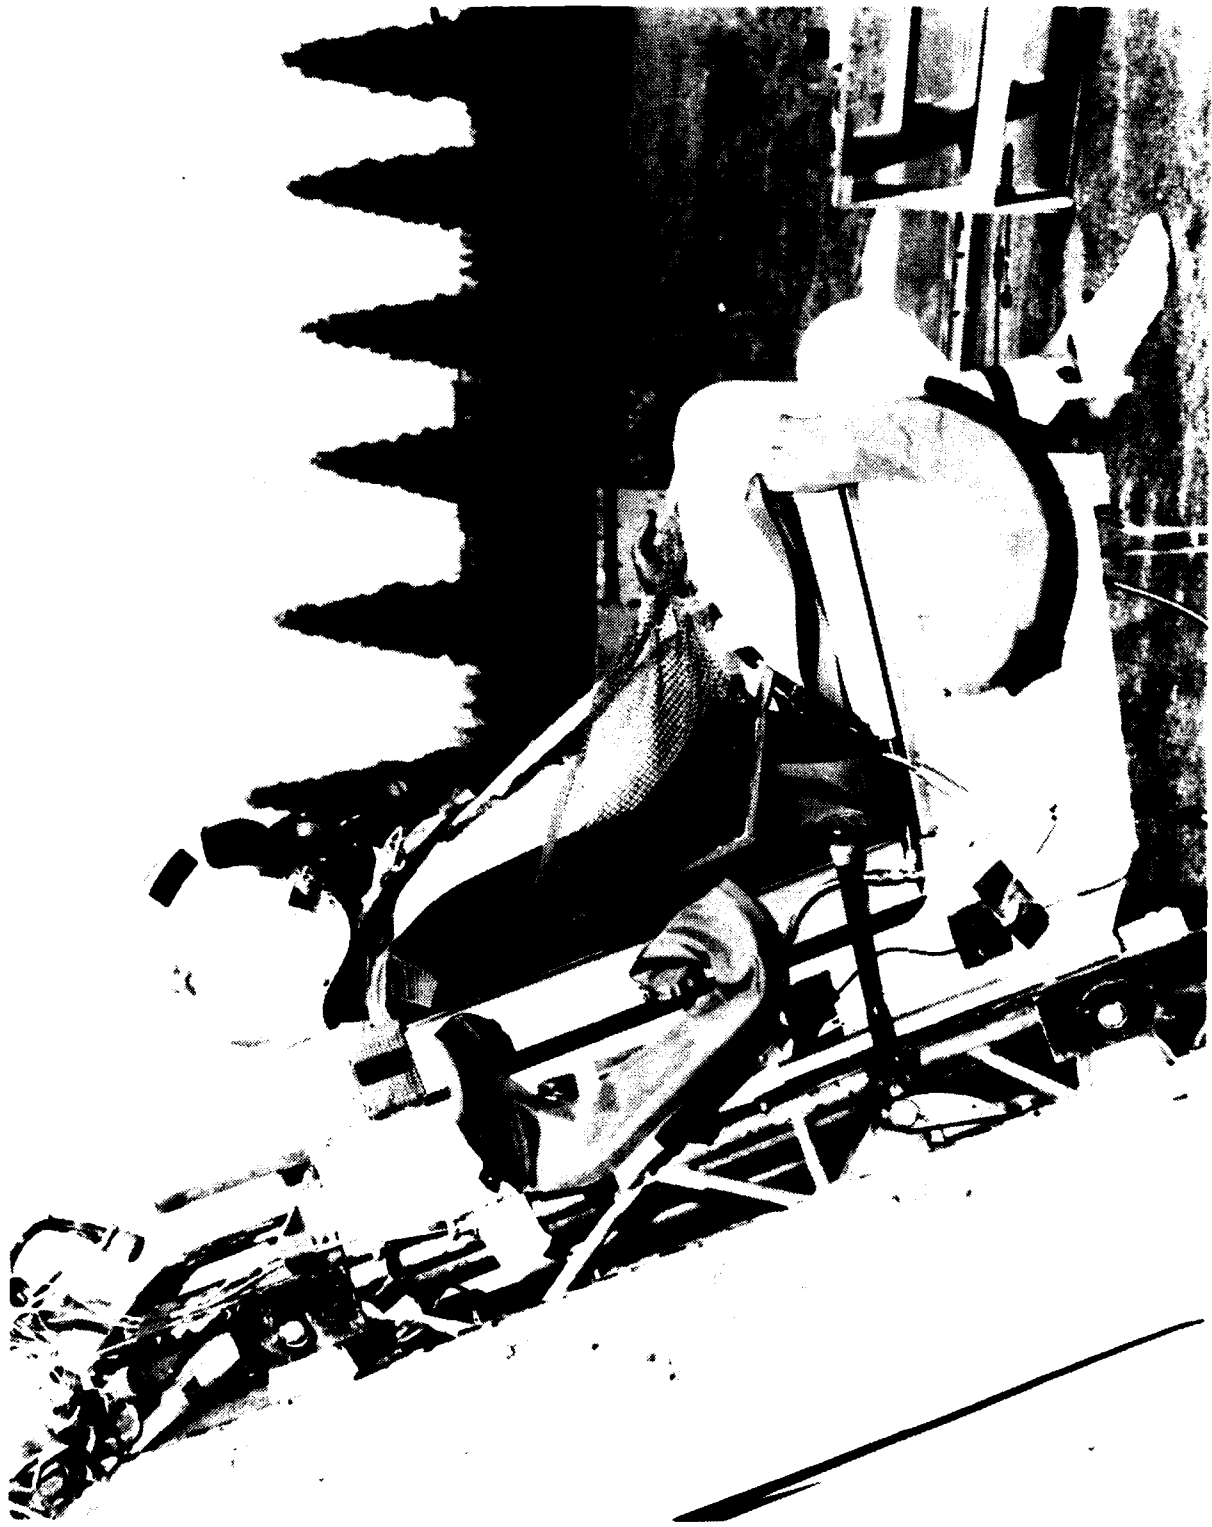
Figure 12. Side View HELPS Properly Cinched

Views of a successful cinch-up are shown in figures 12 and 13. Cinch-up failures occurred because of the following two problems:

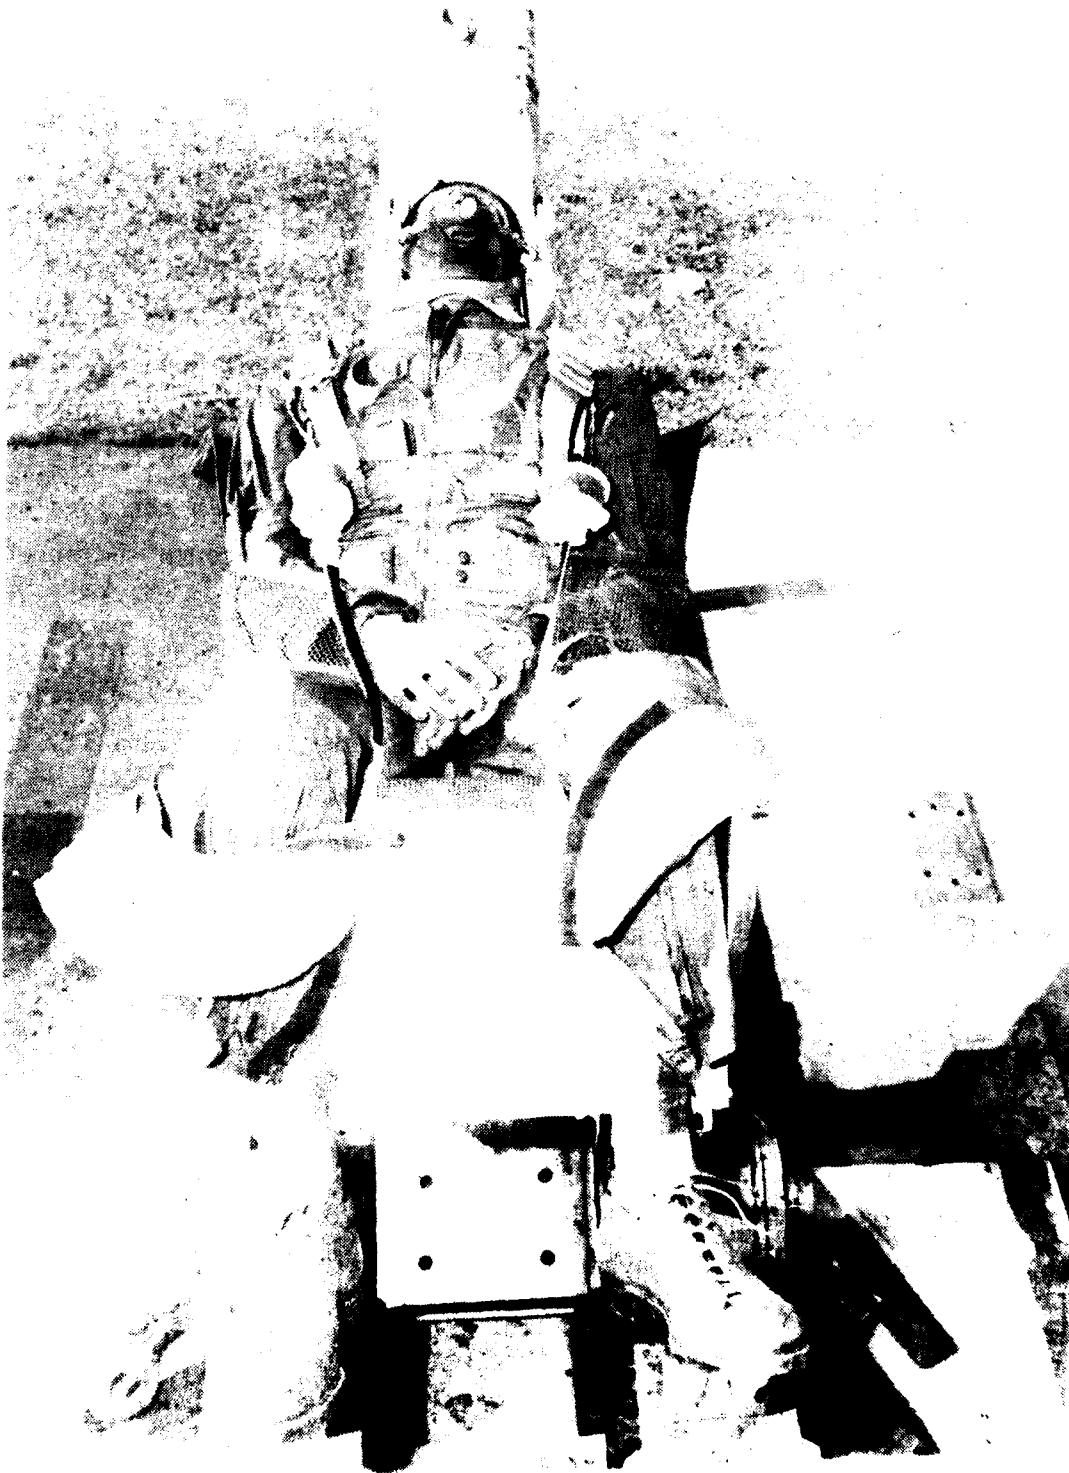
Figure 20. View of HELPS Before Aft Pitch Windblast

Although some undesirable limb motion occurred, the HELPS prevented the dummy's arms and legs from flailing. Considerable arm motion occurred beneath the arm restraint straps and arm restraint netting, but the arms never dislodged from the restraint. The most extreme arm motion is depicted in figures 20 thru 23 which are pre and post test photos of tests 4 and 6. Two factors contributing to this arm motion are a poor connection of the arm restraint straps to the inertia reel straps, and weak stitching holding the arm restraint netting to the seat sides and the arm restraint straps. These factors allowed the HELPS to loosen as load was being applied by the arms. Downward lateral leg displacement occurred in test 8, but the legs always remained against the front of the seat bucket. Figures 24 and 25 show this motion. This motion occurred because the strap snubber was not able to restrain the legs against the applied windblast load. As the strap pulled back through the snubber, slack was introduced throughout the system.
